## Springfield Museum

### Collection Assessment for Preservation (CAP) Assessor's Report

October 9th, 2018

Final Report

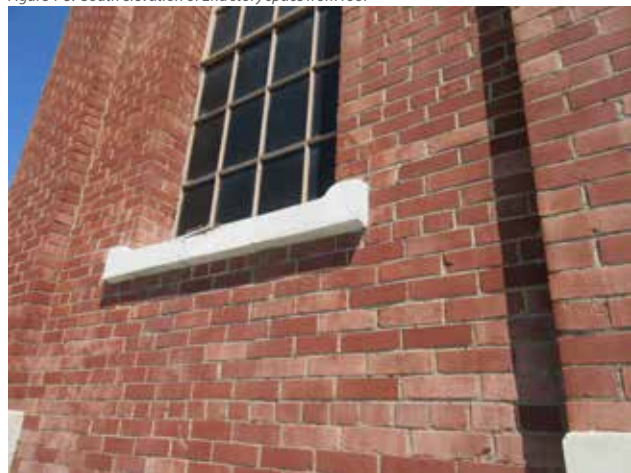
Mortar joints were repointed in 2011 and a major repair project in 2013 replaced damaged masonry and missing mortar on the west elevation. Some cracking and spalling of the pre-cast window sills on the two-story south elevation are occurring and the mortar wash around the roof access hatch has failed. The east exit wood door is exposed to the sun and weather and requires refinishing. The single ply roof system is nearing the end of its life (installed 20 + years) and should be scheduled for near term replacement. Roof top mechanical units are also at end of life cycle. The restroom hot water heater has no spill pan and a leak could damage adjacent phone and security systems.

Figure 1-6: Spalling concrete at window sill

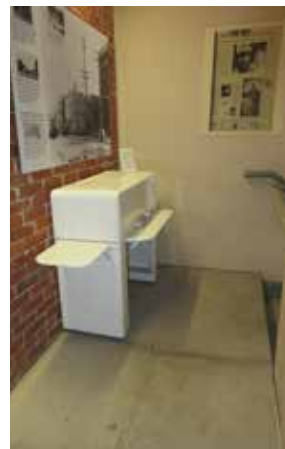
Figure 1-9: Display within exit path

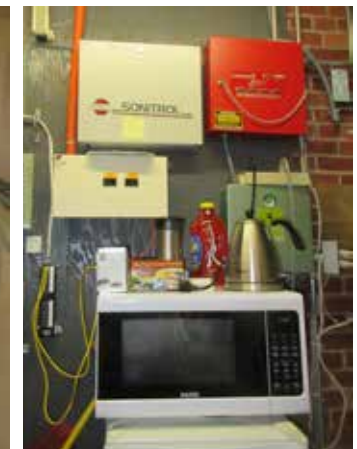
Figure 1-10: Breakroom within sensitive electronic equip.

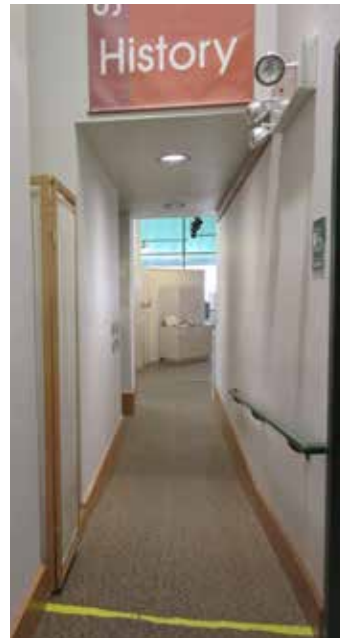
Figure 1-11: (e) Hallway from exhibit to staff area, serves as egress path

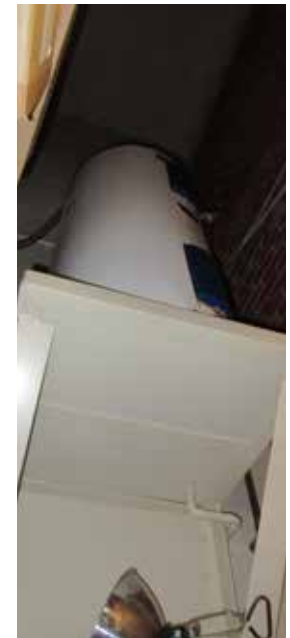
Figure 1-12: Hot water tank within electrical closet

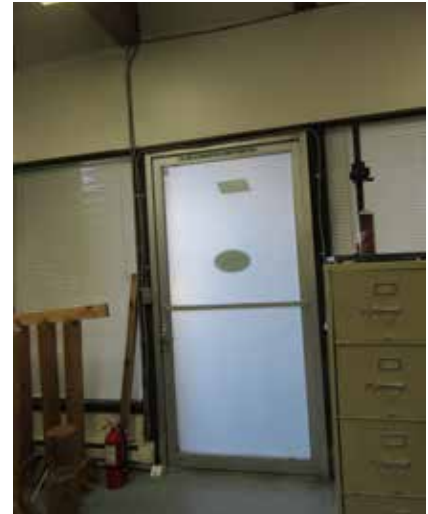
Figure 1-14: Booth Kelly entry. No emergency egress hardware.

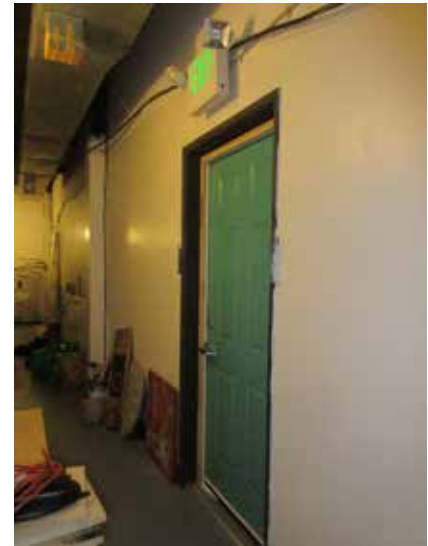
Figure 1-15: Booth Kelly egress exit showing improper egress lighting location and improper exit door hardware.

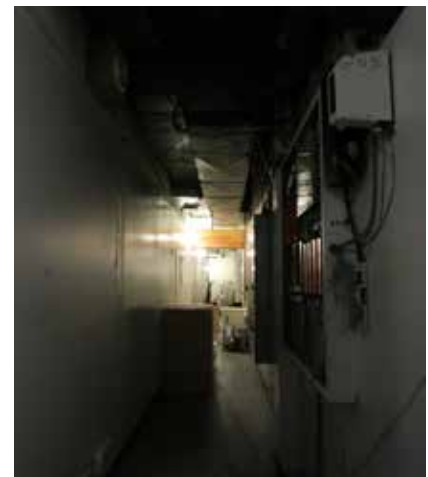
Figure 1-16: Booth Kelly blocked exist pathway

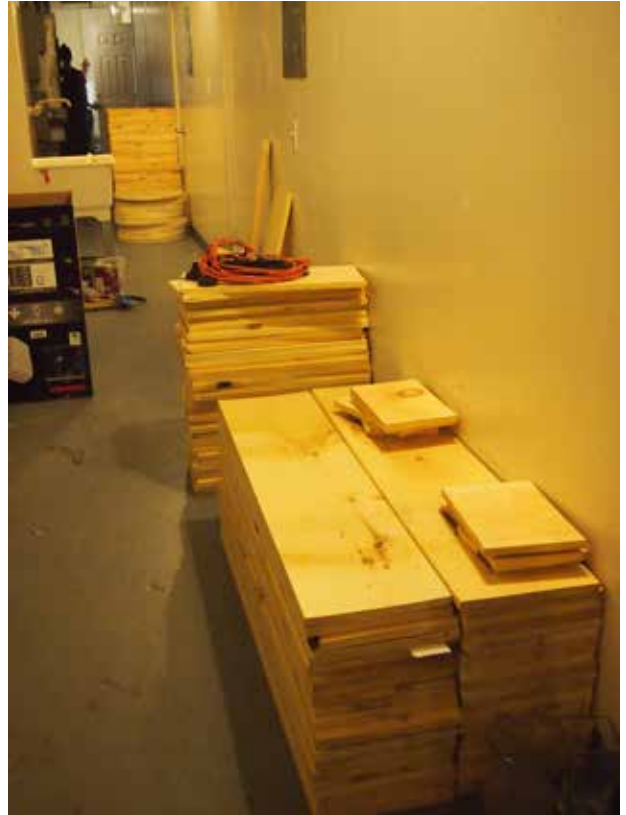
▲ Figure 1: The rear corridor of the Booth-Kelly off-site storage facility showing its use for storing flammable materials and generally being obstructed making safe and easy egress impossible. Specific space issues, as they impact the collections, will be discussed elsewhere in this document in the section headed "STORAGE".

- Address the current conditions at, and use of, the Booth-Kelly Business Complex location – The storage unit at Booth-Kelly is not an appropriate space for the care and security of collections, or as a place of work for museum staff. Preferably alternative space should be found, or the current use of the space should be reviewed and adjusted so that no collections objects are housed there. At a minimum conditions at the space should be improved, including better locks, the clearing out of the back corridor of all obstacles and flammable materials, and the installation of the required emergency exit route signage.

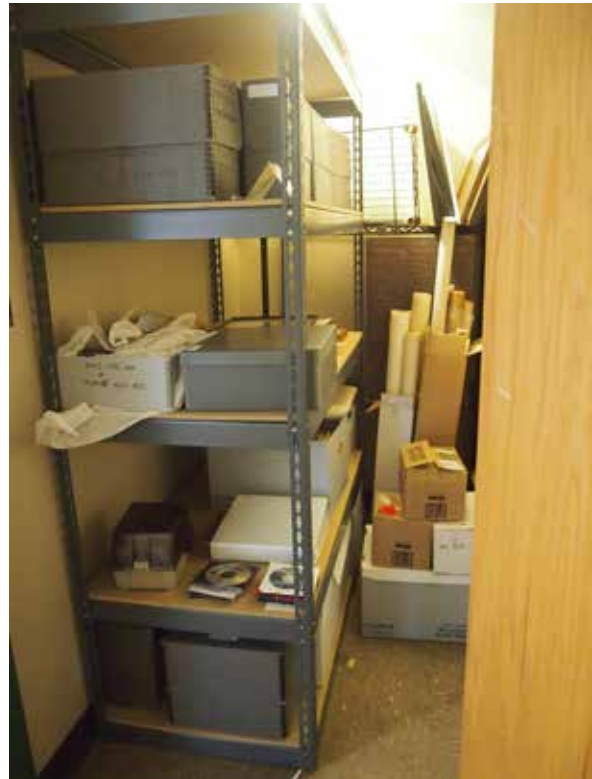
▲ Figure 2: The photograph storage space. Non-collection items can also be seen in this space.

- Relocate photograph collection – The photograph collection needs to be moved to a more suitable and environmentally appropriate location as soon as possible. Its current site appears to be causing the active deterioration of this material due to excessive temperatures and lack of ventilation.

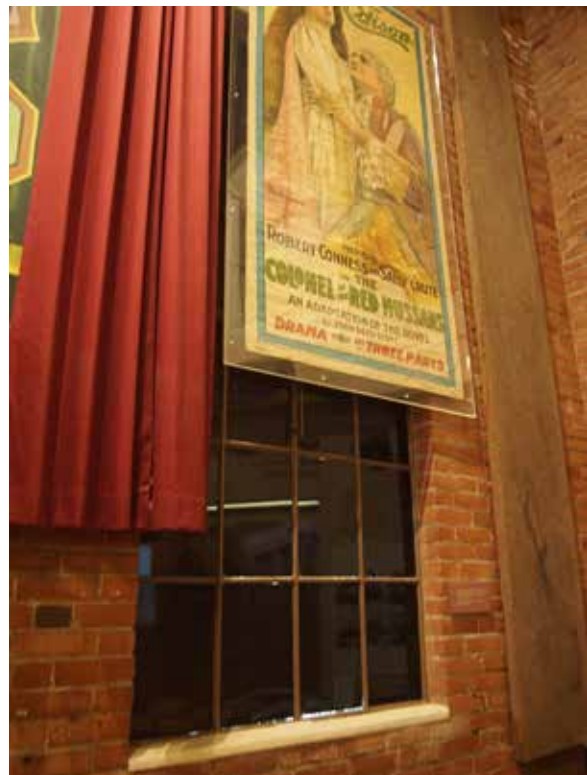
Movie poster “Colonel of the Red Hussars”, permanent exhibition area – This large movie poster, mounted between sheets of plexiglass, has been hung directly in front of a large window which has been blacked out by painting the glass black (Figure 3.). At the time of the assessment the weather was overly warm and sunny leaving the glass very hot to the touch and noticeably radiating an excessive amount of heat into the room. This heat is being trapped between the window and the back of the poster and is undoubtedly causing damage to the object.

▲ Figure 3: The large “Colonel of the Red Hussars” movie poster hung in a blacked out window which is radiating excessive amount of heat and likely causing damage to the object.

The poster should be displayed away from any source of direct heat or sunlight. However, due to its large size, reinstallation elsewhere may not be possible. If it must remain on exhibit, the window should be covered with an insulating layer (such as insulated curtaining) to reduce the amount of heat coming in contact with the object.

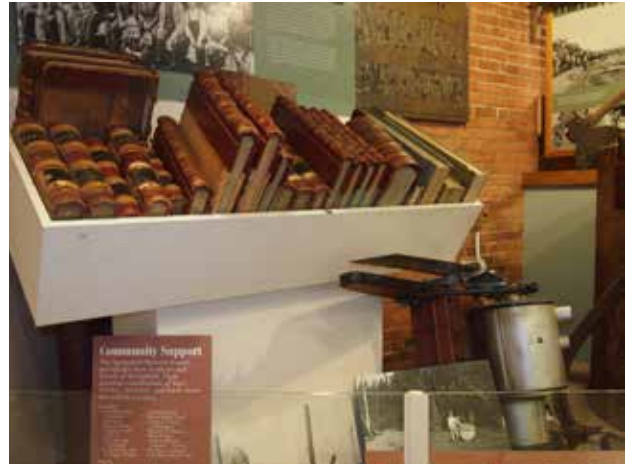
▲ Figure 6: An example of a display in the permanent exhibition area showing the low, barrier meant to deter visitors from accessing the exhibit. However, much of the display (in particular in this example a group of ledgers) is clearly well within reach.

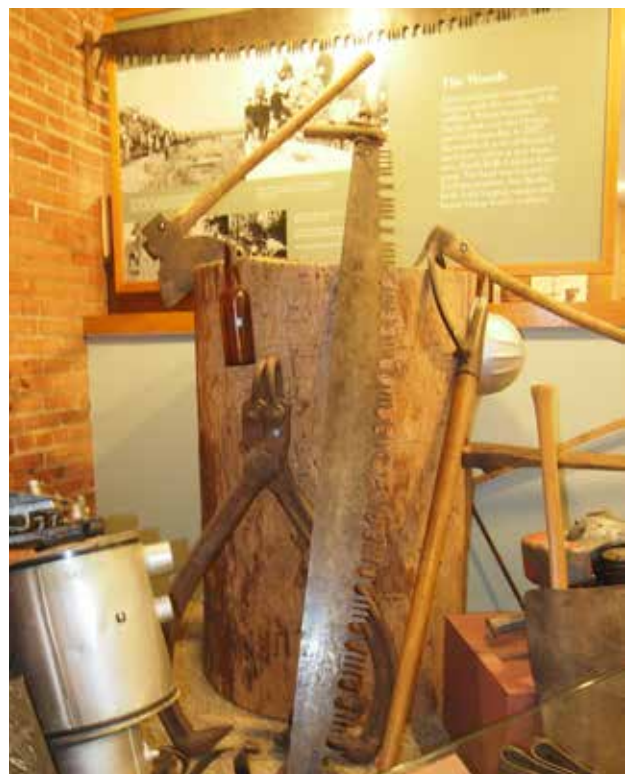
▲ Figure 7: An example of a large object – a two-handed logging saw – dangerously displayed leaning against a large section of log. The close proximity of the public barrier can be seen in the foreground.

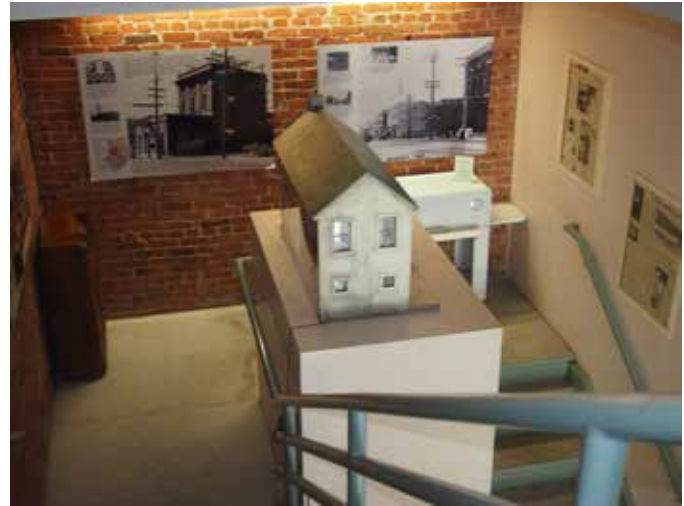
On the landing, half way up the staircase between the first and second floor are three large objects (Figure 8). These are vulnerable to being touched and/or accidentally damaged as people pass up and down the stairs. They are also obstacles to the safe egress of visitors between the floors in an emergency. They should be removed and repositioned or placed in storage for the safety of the objects and visitors.

▲ Figure 8: The stairwell between the first and second floors of the museum. There are three large collection objects exhibited in this space with no barriers to prevent touching. The two placed on the pathway are also obstacles to safe egress from the building in the event of an emergency.

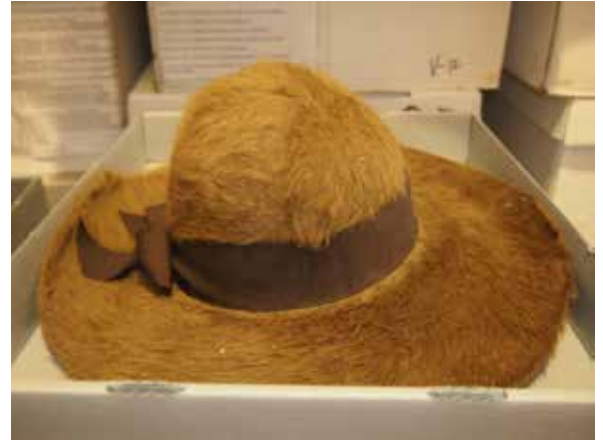
▲ Figure 9: An example of a hat being housed on a try that is too small, forcing the brim to be pushed up, a distortion that may become permanent if the object is not rehoused appropriately in the near future.

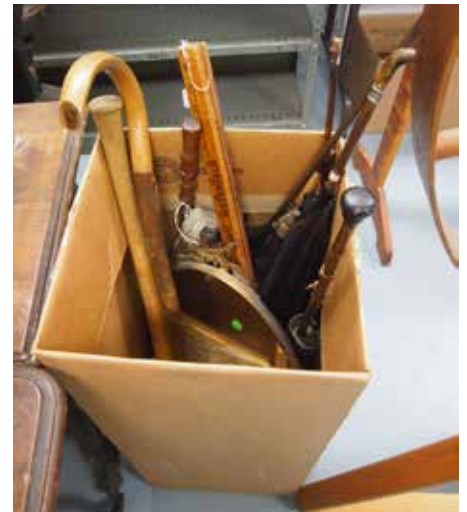
▲ Figure 10: An example of a box of mixed objects with insufficient packing materials around each item.

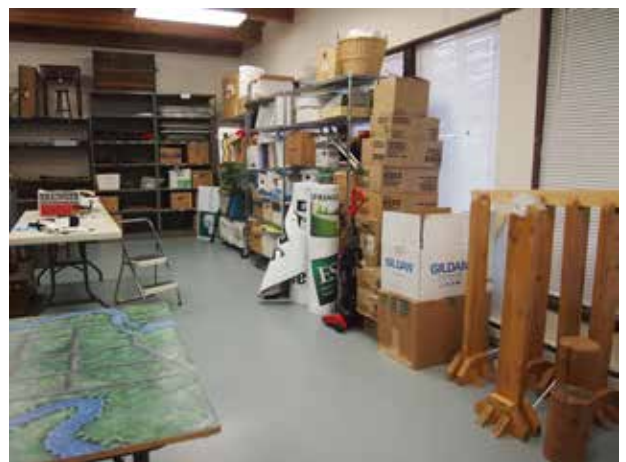
▲ Figure 11: An example of non-collections and collections items stored together in the same location – in this case at the Booth-Kelly storage facility.

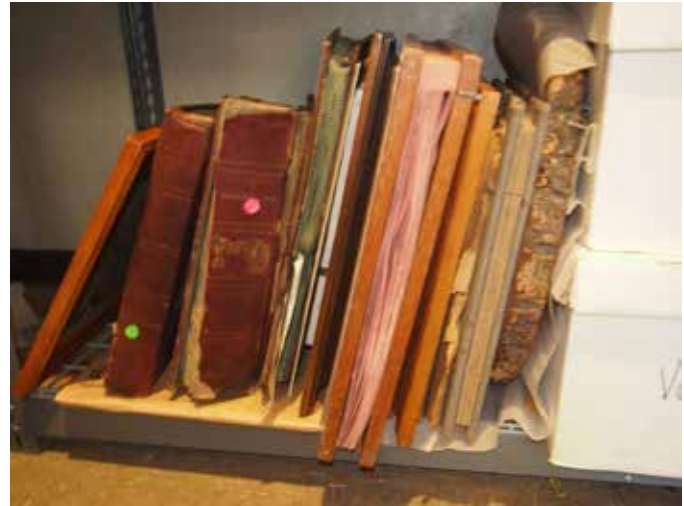
There is a general need for the collections to be sorted, storage areas rearranged to better use them, and a comprehensive project to rehouse and improve the packing of items in storage (Figure 12).

▲ Figure 12: Another example of objects incorrectly housed and stored, in this case a group of books without any protection to their surfaces and with no physical support other than each other.

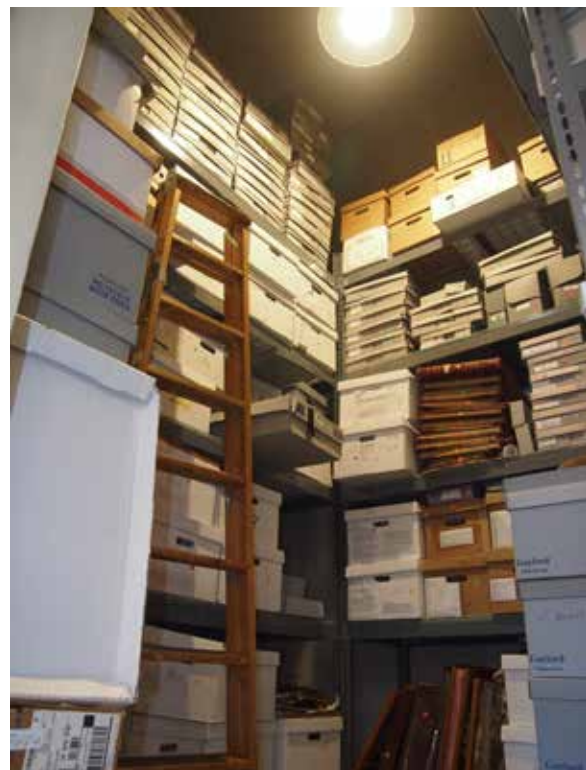
The Vault – The vault is the largest secure collection area in the museum and it is situated off the rotating gallery space (Figures 13 and 14). It consists of a single small room with an exceptionally high (over 12 feet) ceiling, Three walls are lined with single depth shelving, but with insufficient separating shelves leading to the over stacking of boxes. Boxes are also stacked almost to the ceiling making retrieval of the top ones difficult and risky. The fourth wall – that to the immediate left as you enter – is lined with boxes and other containers stacked on top of each other, the bottom ones being directly on the floor. There is simply too much crammed into this room for it to be accessed safely or usefully.

▲ Figure 14: The interior of the Vault showing its very high ceiling. The over stacking of boxes and general overcrowded conditions of the shelves can clearly be seen.

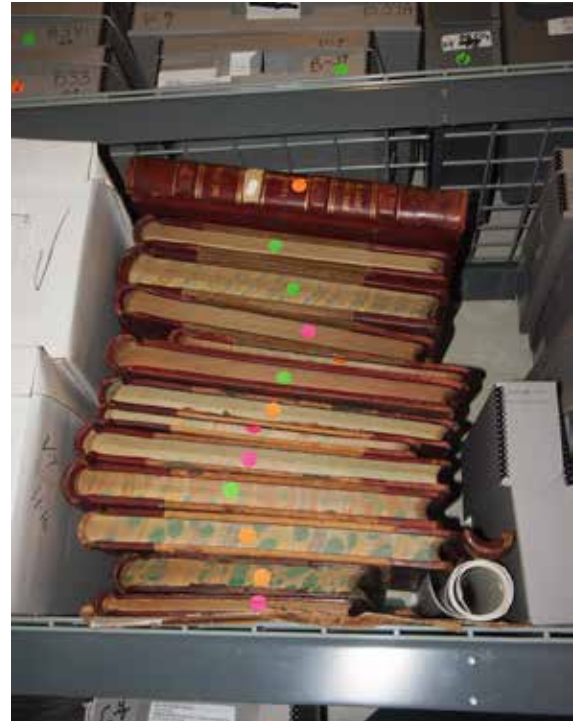
There is a group of oversized ledgers stacked on top of each other without benefit of the protection of boxes or similar container and according to notes left by the previous Curator, this has led to the detachment of one of the spines (Figure 15).

▲ Figure 15: A group of oversized, very heavy ledgers stacked one on top of the other in the Vault storage. The stack is visibly leaning and clearly unstable, not to mention the exposed, unprotected surfaces leaving this group of objects prone to accidental damage when being moved, or when items are moved around them.

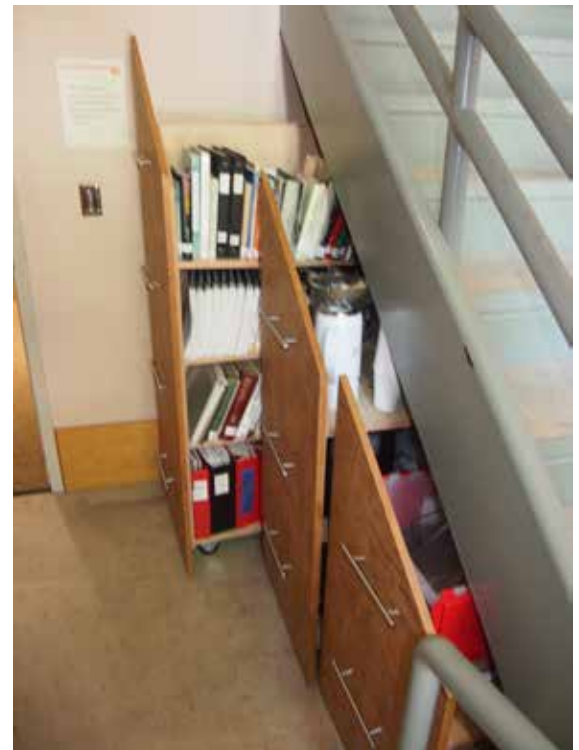
Adjacent to this rolling cart are other, similar units used to store non-collection items including containers and equipment used for food preparation. It is easy for these carts to be bumped against the library cart, presenting the risk of damage to the books.

▲ Figure 16: The library is housed on the rolling cart to the back of this photograph. The two adjacent carts hold food preparation related items and other general, non-collections supplies.

While this area can continue to be used to store the library, thought should be given to relocating it to a safer and more user-friendly location in the future.

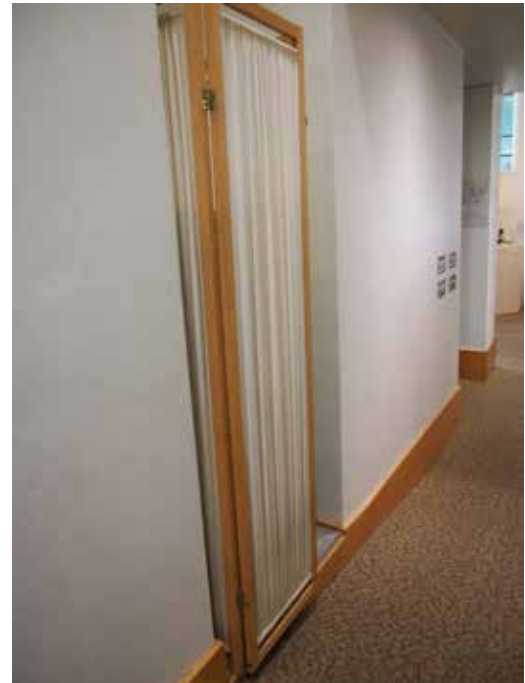
Document Storage Cabinet – Situated in a side niche along the corridor where the restrooms are located on the first floor is a four-drawer, unlocked filing cabinet in which documents and other archive items are stored (Figure 17). It opens out into the corridor and is hidden from view by a fabric screen. This is not an ideal location for collection storage as it is unsecured and in a public area, despite being hidden from view. This cabinet needs to be relocated to a more secure place not directly accessible by the public.

▲ Figure 17: The unsecured, document storage filing cabinet is located behind the fabric screen to the left in this public corridor

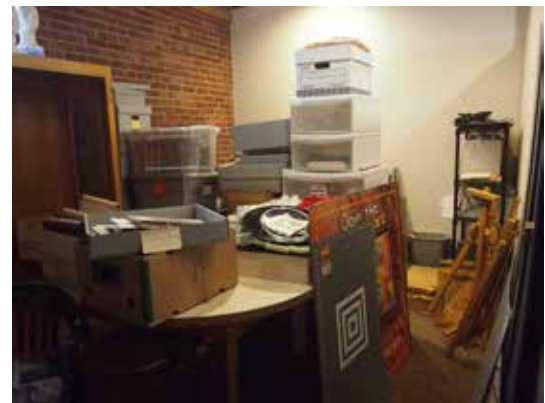
▲ Figure 18: The screened off storage/work space adjacent to the Curator's office. Out of necessity it is being used more as a storage area than a much needed work space.

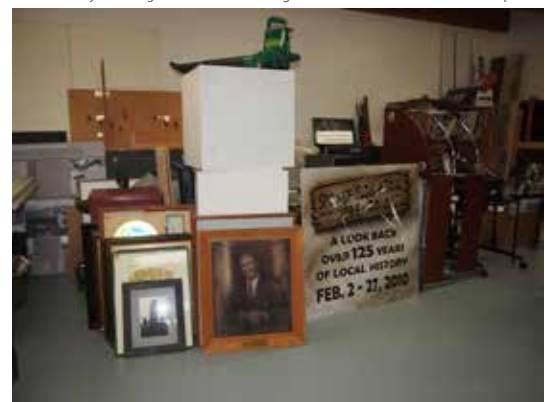
▲ Figure 19: Another example of the mixed storage of collection objects and non-collection items, Booth-Kelly storage facility.
