## Springfield Museum

### Collection Assessment for Preservation (CAP) Assessor's Report

October 9th, 2018

Final Report

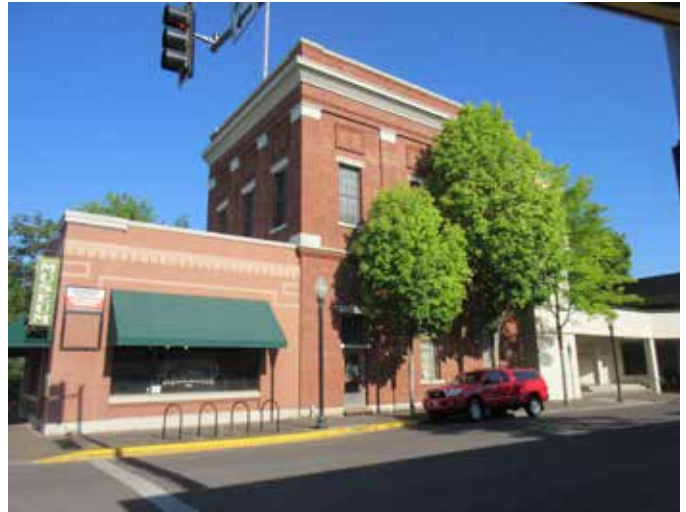
▲ Figure 1-1: Springfield Museum east elevation

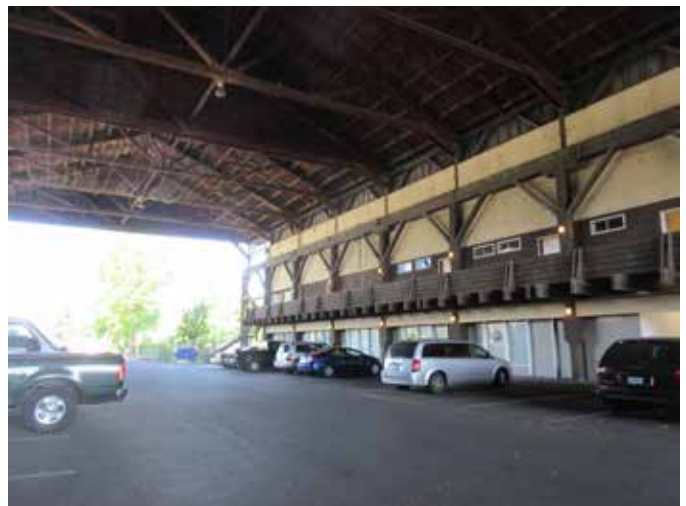
▲ Figure 1-3: Booth Kelly Off-site Storage

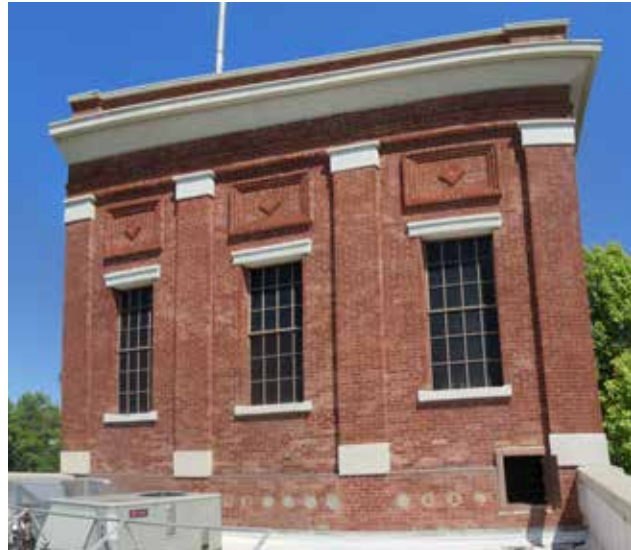
Mortar joints were repointed in 2011 and a major repair project in 2013 replaced damaged masonry and missing mortar on the west elevation. Some cracking and spalling of the pre-cast window sills on the two-story south elevation are occurring and the mortar wash around the roof access hatch has failed. The east exit wood door is exposed to the sun and weather and requires refinishing. The single ply roof system is nearing the end of its life (installed 20 + years) and should be scheduled for near term replacement. Roof top mechanical units are also at end of life cycle. The restroom hot water heater has no spill pan and a leak could damage adjacent phone and security systems.

Figure 1-5: South elevation of 2nd story space from roof

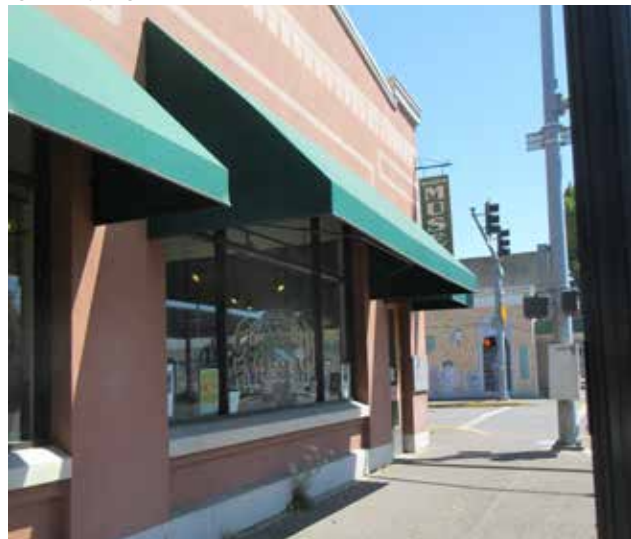
Figure 1-7: Main entry elevation

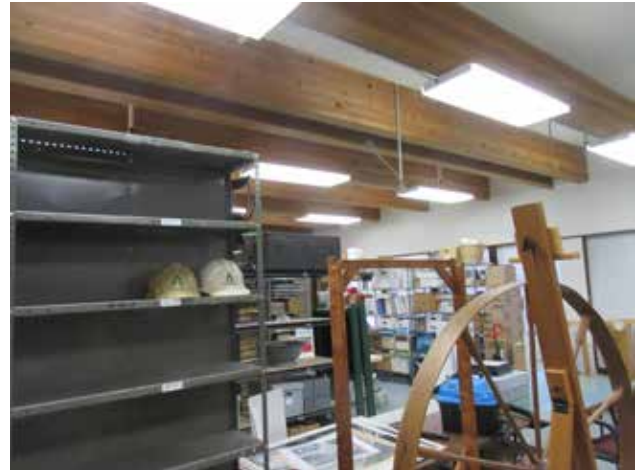
There are no apparent deficiencies of materials in the storage area.

Figure 1-8: Interior Booth Kelly off-site storage

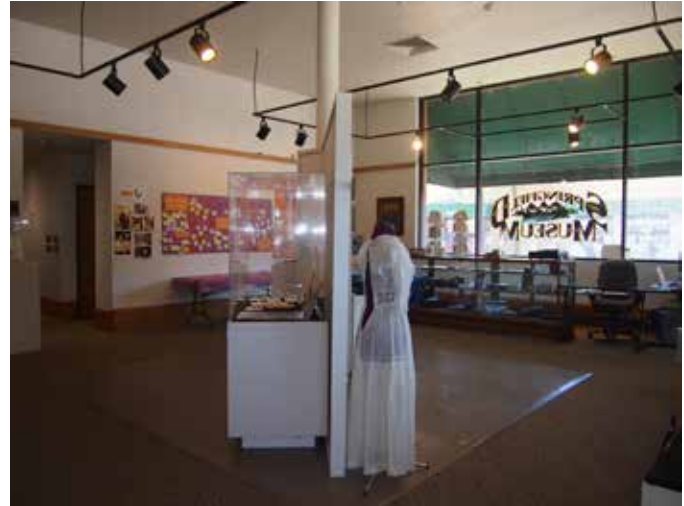
The space also houses the front desk, gift shop and an interactive area where visitors can leave messages and comments about their experience visiting the museum. It is used as a venue for special events, either privately rented or in house, such as opening receptions and the monthly Springfield Art Walk (Figure 4.).

▲ Figure 4: A general view of the rotating gallery space with the gift shop and front desk areas in the background to the right of the photograph.

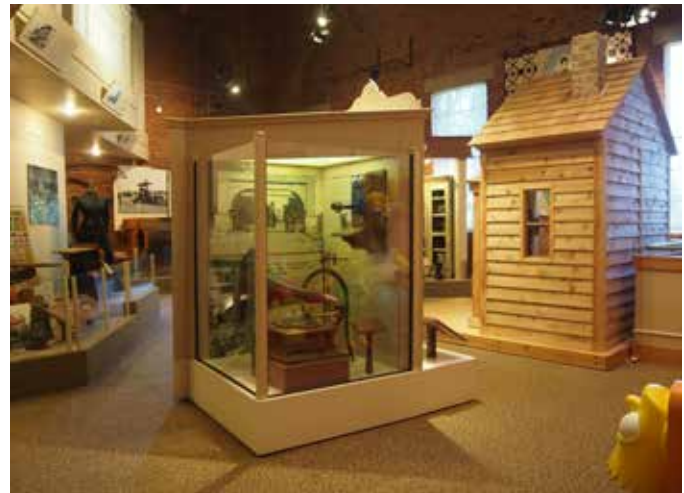
▲ Figure 5: A general view of the permanent exhibit space on the second floor.

The second floor is given over to the museum's permanent exhibition. This comprises a series of display areas featuring objects illustrating specific topics of local interest or history (Figure 5). These areas are easily accessible to the public with few if any barriers to prevent touching. Indeed, one of these areas was the subject of a theft a matter of a few weeks ago when a doll was taken (Figure 6).

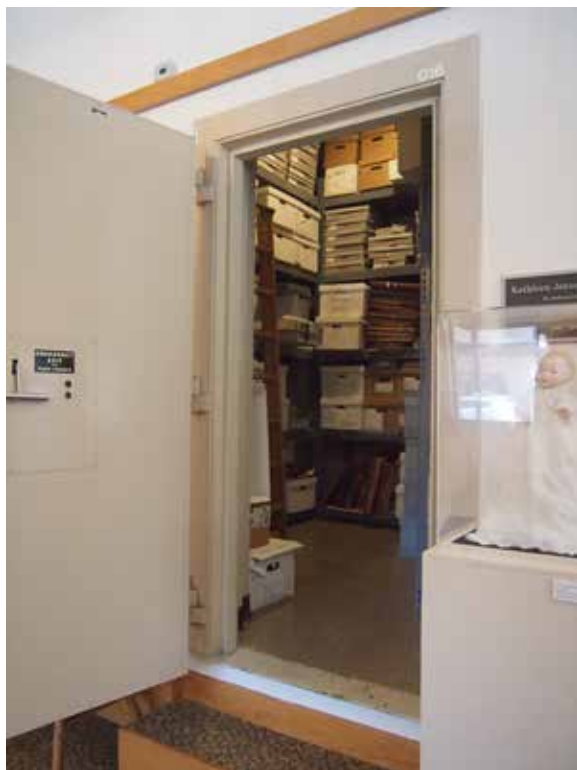
Also, in the room is access to “The Vault”, the main, secure collections storage space. This is kept locked, however, it does open onto a public space which inherently poses a security problem should it need to be accessed during museum visiting hours.

The Vault – The vault is the largest secure collection area in the museum and it is situated off the rotating gallery space (Figures 13 and 14). It consists of a single small room with an exceptionally high (over 12 feet) ceiling, Three walls are lined with single depth shelving, but with insufficient separating shelves leading to the over stacking of boxes. Boxes are also stacked almost to the ceiling making retrieval of the top ones difficult and risky. The fourth wall – that to the immediate left as you enter – is lined with boxes and other containers stacked on top of each other, the bottom ones being directly on the floor. There is simply too much crammed into this room for it to be accessed safely or usefully.

▲ Figure 13: The door leading into the vault storage room.
