Inventory and Channel Assessment Report For Springfield Waterways

August 2004

Environmental Services, Water Resources

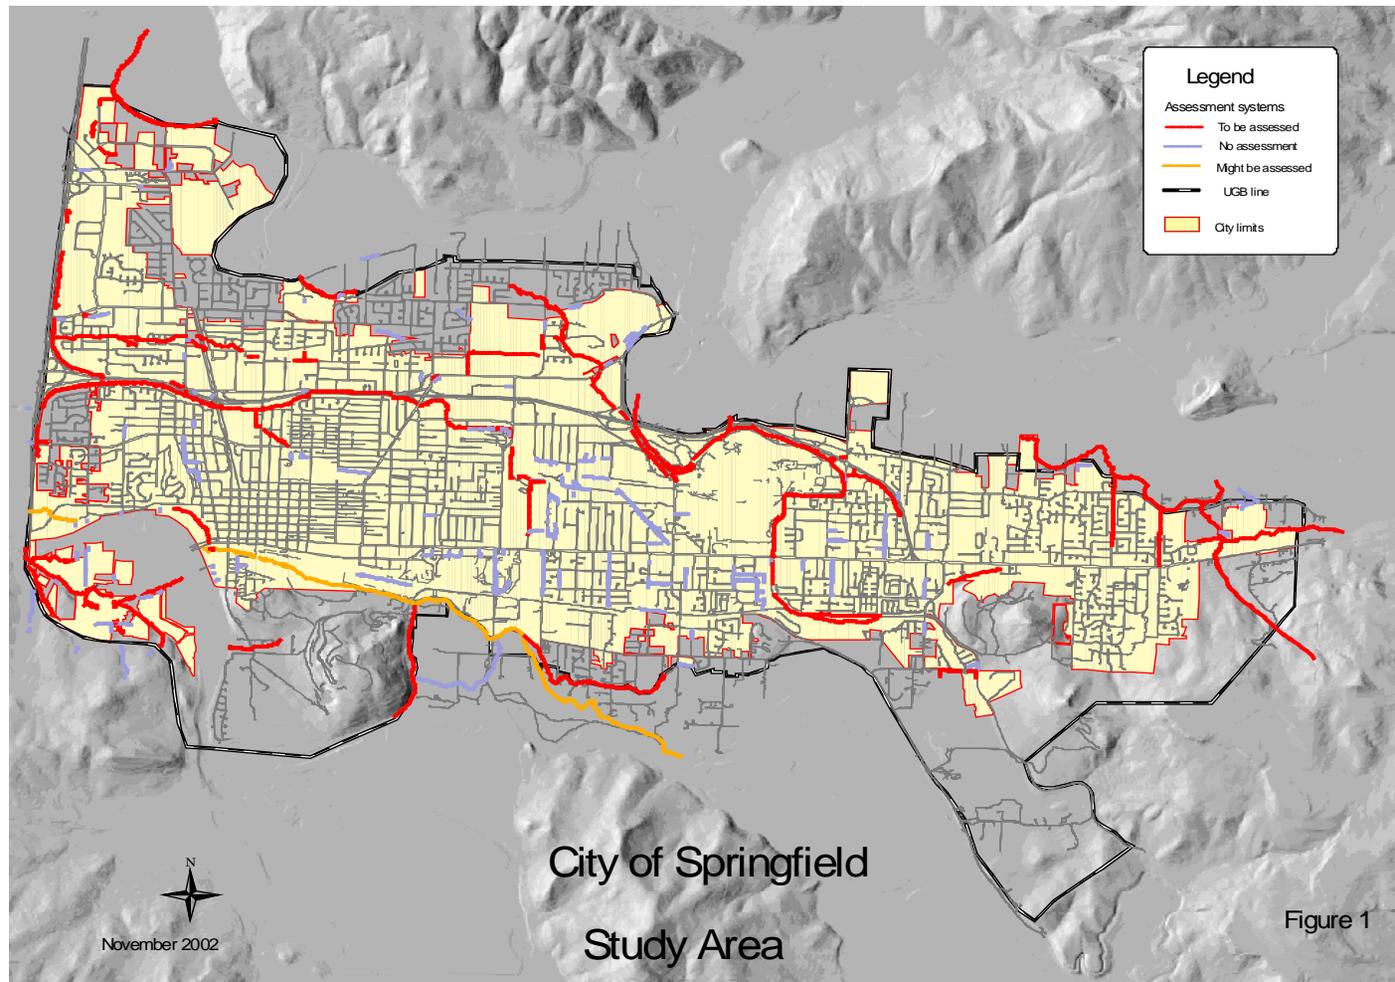
In June 2002, the Water Resources section of the Environmental Services Division for the City conducted a city-wide inventory and assessment of all surface drainage stream and channel systems that discharge to the Willamette and McKenzie Rivers. At the time of this assessment 44 stream systems within the Urban Growth Boundary (UGB) had been identified for the assessment study area. See figure 1, study map.

Figures	
Figure 1 Study Area Map	3
Figure 2 Waster Resource Integrity Chart	6

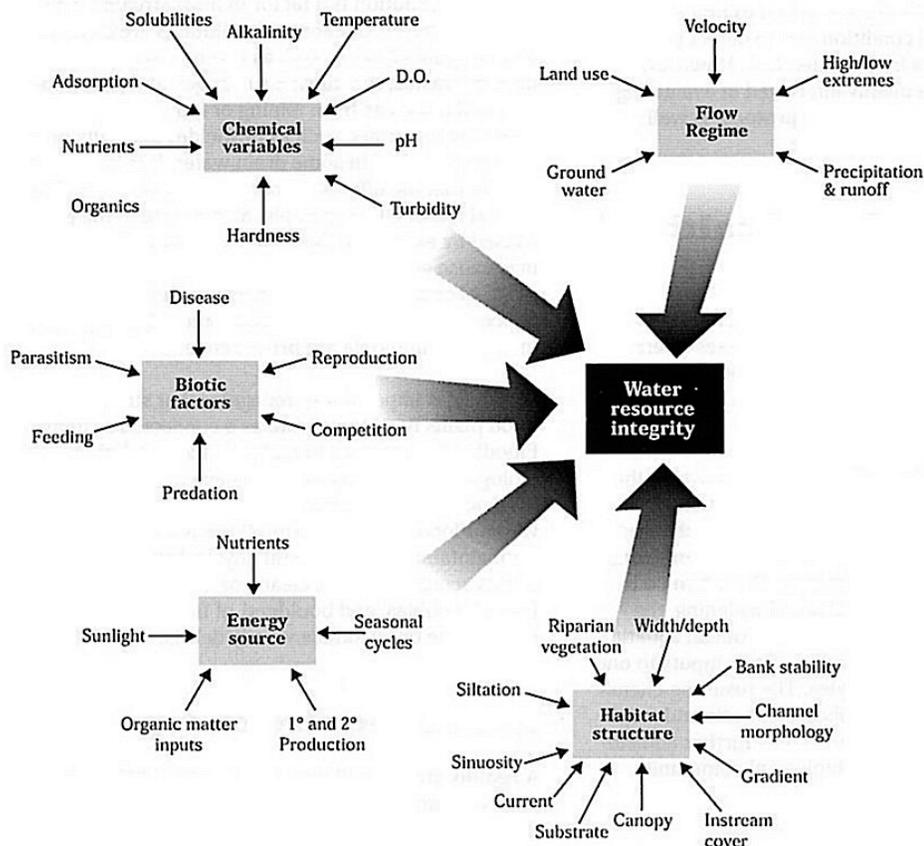
Figure 2 Factors that influence the integrity of streams (modified from Karr 1986)

A stream is a complex ecosystem in which several biological, physical, and chemical processes interact. Changes in any one characteristic or process have cascading affects throughout the system (see figure 2). Due to the complexity and changing nature of these variables not all influences in the chart could be investigated. However, this scoring and rating methodology attempts to record the most critical elements of a stream system.

The scoring of each reach was then totaled and divided by the number of categories scored. This returned an overall health rating. The overall health ratings are based on the functional value of a stream or channel system. Functional values are benefits provided by resources (see figure 2). The ratings return a value that is interpreted as poor (<6.0), fair (6.1 - 7.4), good (7.5 - 8.9), and excellent (>9.0), this numeric value represents the “Functional Value” of the system or reach. The functional value can be used as a general statement about the “state of the environment”, or over a period of time as an indicator of “trends” in the conditions, or as a baseline study to characterize health.
